Changes in Vegetation and Geomorphological Condition 10 Years after Riparian Restoration

Abstract: Riparian restoration is an important objective for landscape managers seeking to redress the widespread degradation of riparian areas and the ecosystem services they provide. This study investigated the long-term outcomes of ‘one-off’ restoration activities undertaken in the Upper Murrumbidgee Catchment, NSW, Australia. The objective of the restoration was to protect and enhance riparian vegetation and control erosion, and consequently reduce sediment and nutrient delivery into the Murrumbidgee River. To evaluate the outcomes 10 years after restoration, rapid riparian vegetation and geomorphological assessments were undertaken at 29 sites spanning the four different restoration methods used (at least five replicates per treatment), as well as at nine comparable untreated sites. We also trialed the use of aerial imagery to compare width of riparian canopy vegetation and projective foliage cover prior to restoration with that observed after 10 years. Aerial imagery demonstrated the width of riparian canopy vegetation and projective foliage cover increased in all restored sites, especia

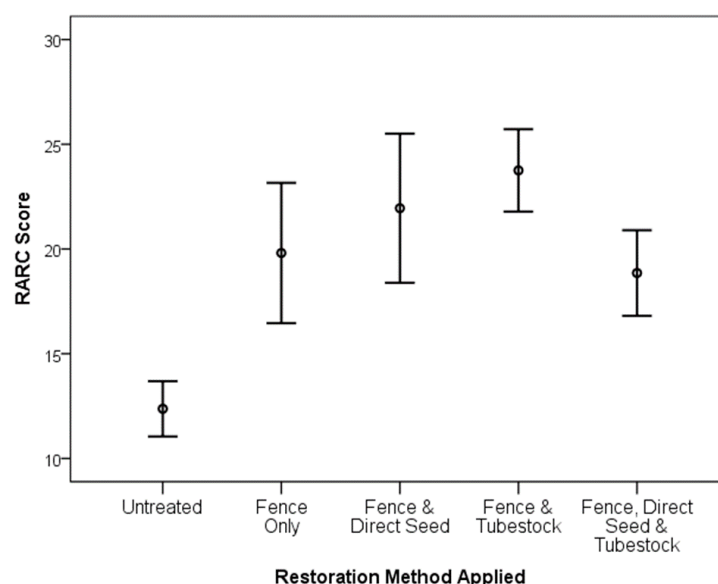
Figure 2. Mean riparian vegetation condition (RARC) scores 10 years after restoration for sites restored as part of the Bidgee Banks Restoration Project (BBRP) using four restoration methods (see Table 1). Untreated site scores are provided as a comparison. Error bars represent \pm SE. A healthy site RARC score is 43.

The mean riparian vegetation condition (RARC) score across all restored sites and restoration methods was significantly greater at $21.3 \pm 1.3\text{SE}$ 10 years after restoration, compared to 12.4 ± 1.3 for untreated sites ($F = 4.24$; $df = 4,33$; $p < 0.01$; Figure 2). The different restoration methods led to different vegetation condition (Figure 2), with differences between the 12 individual indicators (Figure 3). While the combination of fence and tubestock planting resulted in (i) a higher overall vegetation condition, (ii) the two highest individual site scores (33.1 and 30.6), and (iii) the highest minimum site score (16.7) (Figure 2), no restoration method resulted in the highest scores across all 12 indicators (Figure 3). Five of the 12 individual RARC indicator scores were significantly higher in treated than untreated sites (Figure 3), being: width of riparian canopy vegetation ($F = 5.60$; $df = 4,33$; $p < 0.01$), canopy cover ($F = 4.40$; $df = 4,33$; $p < 0.01$), native mid-storey cover ($F = 3.00$; $df = 4,33$; $p = 0.03$), native canopy cover ($F = 3.76$; $df = 4,33$; $p = 0.01$) and mid-storey species recruitment ($\chi^2 = 10.22$; $p = 0.04$). RARC indicators canopy cover and width of riparian vegetation contributed strongly to the changes in the RARC condition score observed, with the width of riparian vegetation scores being the most correlated with the overall RARC score ($R^2 = 0.629$, $F(1,36) = 61.099$, $p < 0.001$) and canopy cover the third most ($R^2 = 0.586$, $F(1,36) = 51.04$, $p < 0.001$). There was no discernable difference between treated and untreated sites or between treatment (restoration) types for the other seven RARC indicators (Figure 3).

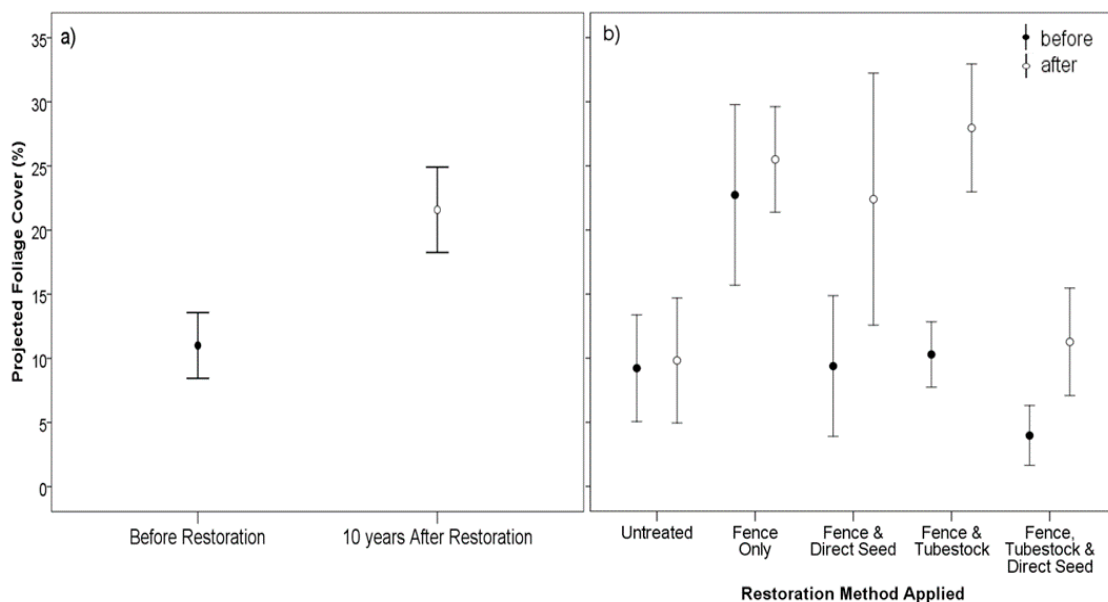
Figure 5. Changes in projective foliage cover from aerial photographs of sites before restoration occurred and 10 years after. Mean projected foliage cover (a) across all treated sites and, (b) for untreated sites and sites restored using each of the four different restoration methods. Closed circles (●) = before restoration, and open circles (○) = 10 years after restoration. Error bars represent ± SE.

The mean projected foliage cover almost doubled following restoration (Figure 5a). The increase was observed to a greater extent where active restoration (tubestock planting and direct seeding) methods were used (Figure 5b). Projected foliage cover did not change in untreated sites over the same timeframe (Figure 5b).
